DELAWARE RIVER BASIN  
SALEM CREEK, SALEM COUNTY  
NEW JERSEY

CAMP KARNEY DAM  
NJ 00106

PHASE 1 INSPECTION REPORT  
NATIONAL DAM SAFETY PROGRAM

August, 1979

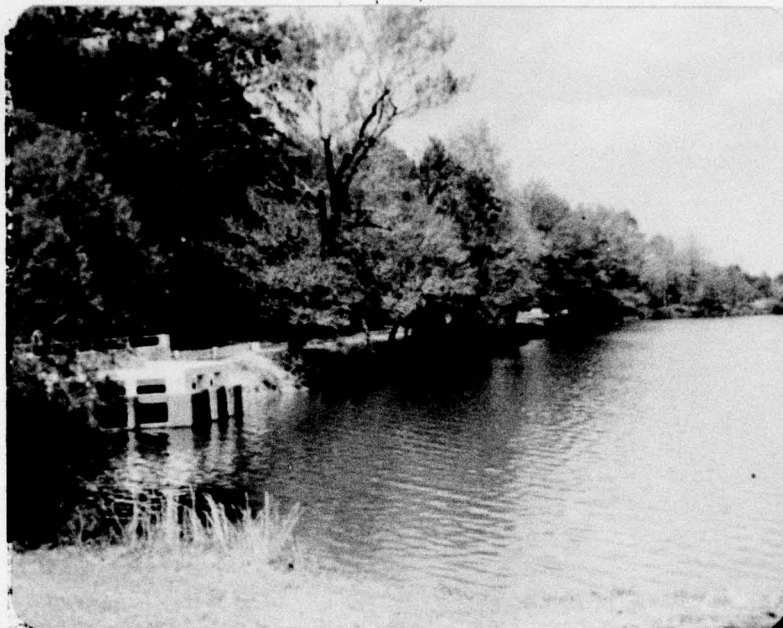
View of Camp Karney Dam

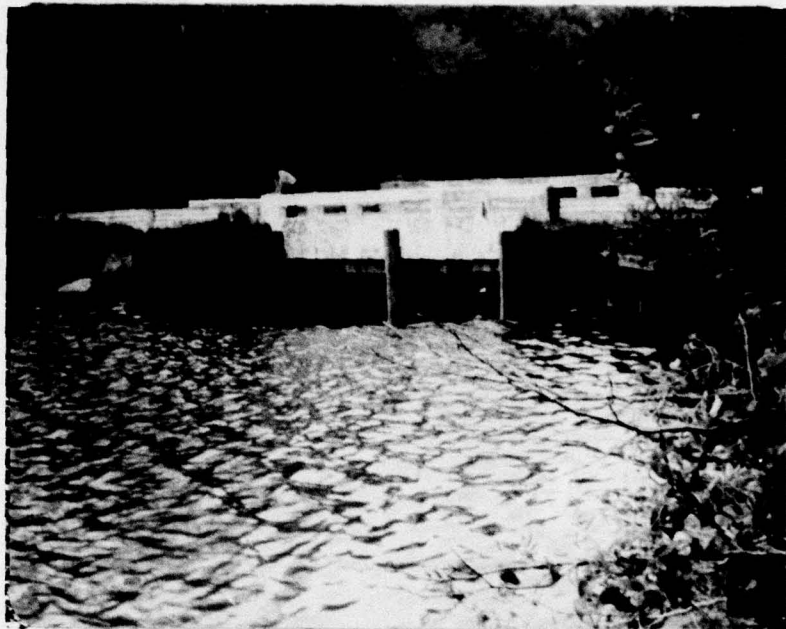
View of Primary Spillway

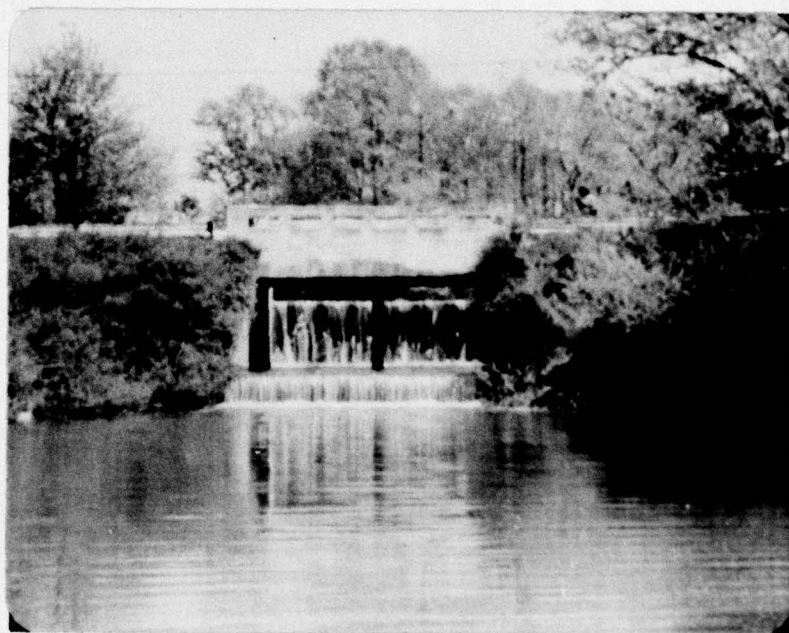
have eroded a large stilling basin several feet deeper than the invert flowline and undercut the paved invert, which extends out about 15 feet beyond the west bridge fascia, a depth of four to five feet. Some type of structural modification has been made on the east side of the super-structure. It appears that old posts were removed, probably during the 1952 spillway construction. However, there is no evidence of major structural cracking. Due to the complete lack of differential settlement, this structure is most probably founded on piles. The spillway sheeting is U.S. Steel Corp. "MZ-22" and according to records, is 20 feet long except at the corners where 24 foot lengths were employed. A height of 7.6 feet is exposed across the 23' radius arch.

Downstream View of Primary Spillway

(3) Place riprap or energy attenuation devices in the downstream main spillway channel to lessen the scouring of the stilling basin and the eventual undercutting of the paved inverts.
